# ENHANCED FIXATION OF UNCEMENTED KNEE REPLACEMENT WITH HYDROXYAPATITE

Mervyn J. Cross, Gregory J. Roger, Mark Holt and Neil Bradbury

## ABSTRACT

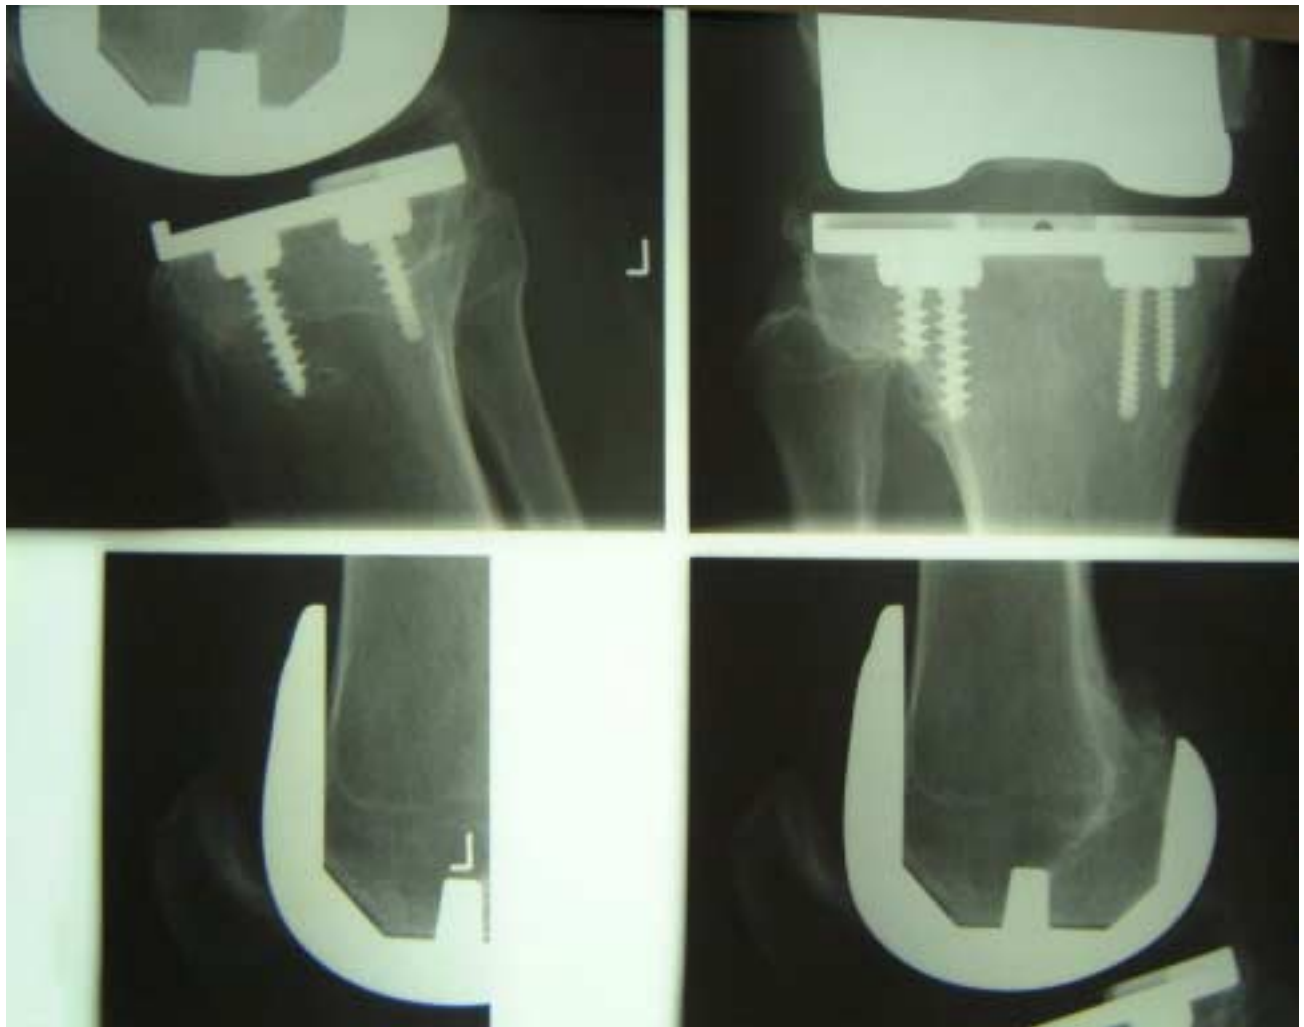
Figure 1. Interface Views

Being an uncemented prosthesis, the quality of the fixation is of paramount importance. In order to examine this, screened views of the bone-prosthesis interface were taken under fluoroscopic positioning (figure 1) immediately postoperatively, and at 2 years. To our knowledge few studies have examined the interfaces in this way [5,9,10]. Because of the minor malpositioning that invariably occurs a true AP or Lateral view of the knee is unlikely to be a true AP or lateral of the prosthesis itself. An apparently true lateral X-ray, for example, when screened into perfect position may then show lucent lines [10] (figure 1). In the few published series, many of the radiographs illustrated are not in fact true laterals or true AP views under close scrutiny and this may hide lucencies.

In a further attempt to standardize the radiographs, the same two experienced radiographers examined all patients in the same fluoroscopy suite. Screened radiographs having been obtained, the position and presence of lucent and also sclerotic lines were noted independently by two independent orthopaedic surgeons unconnected with either the development of the prosthesis or with the clinical management of the patients. A line was said to be present if noted by *either* of the two observers ensuring the false negative rate was as low as possible.

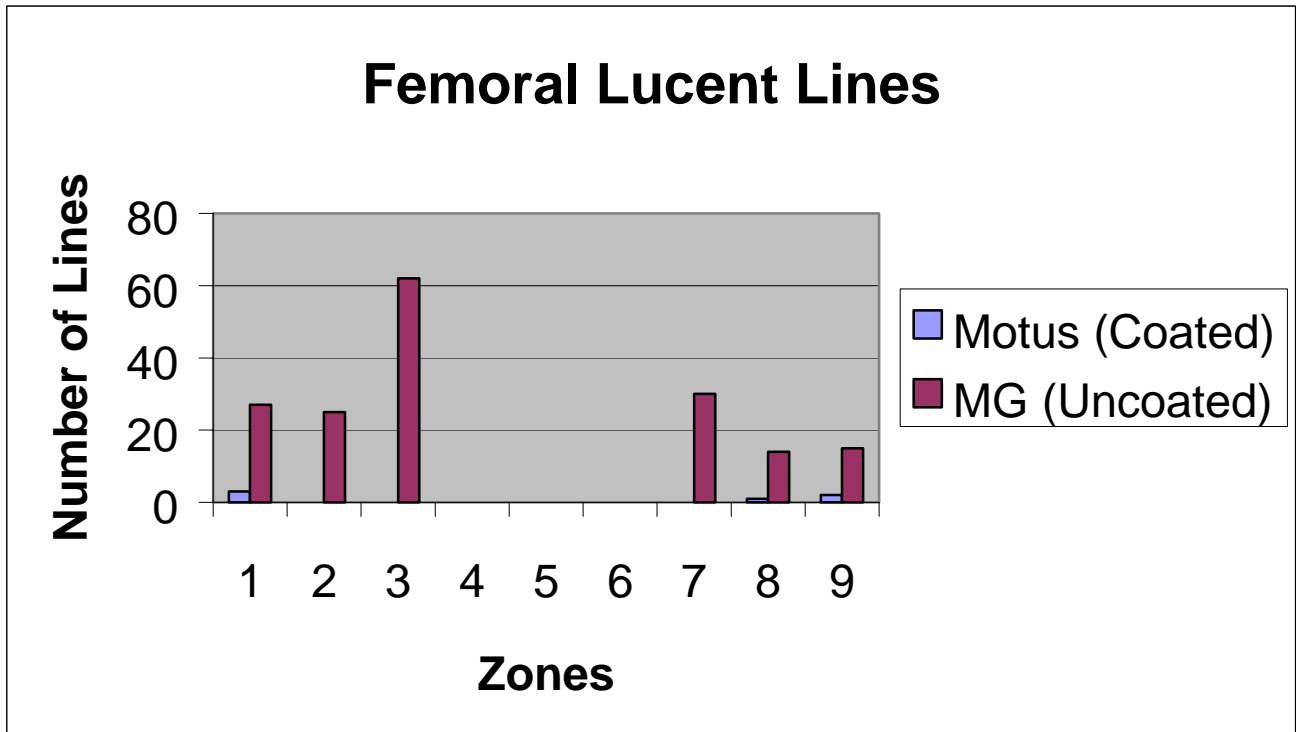
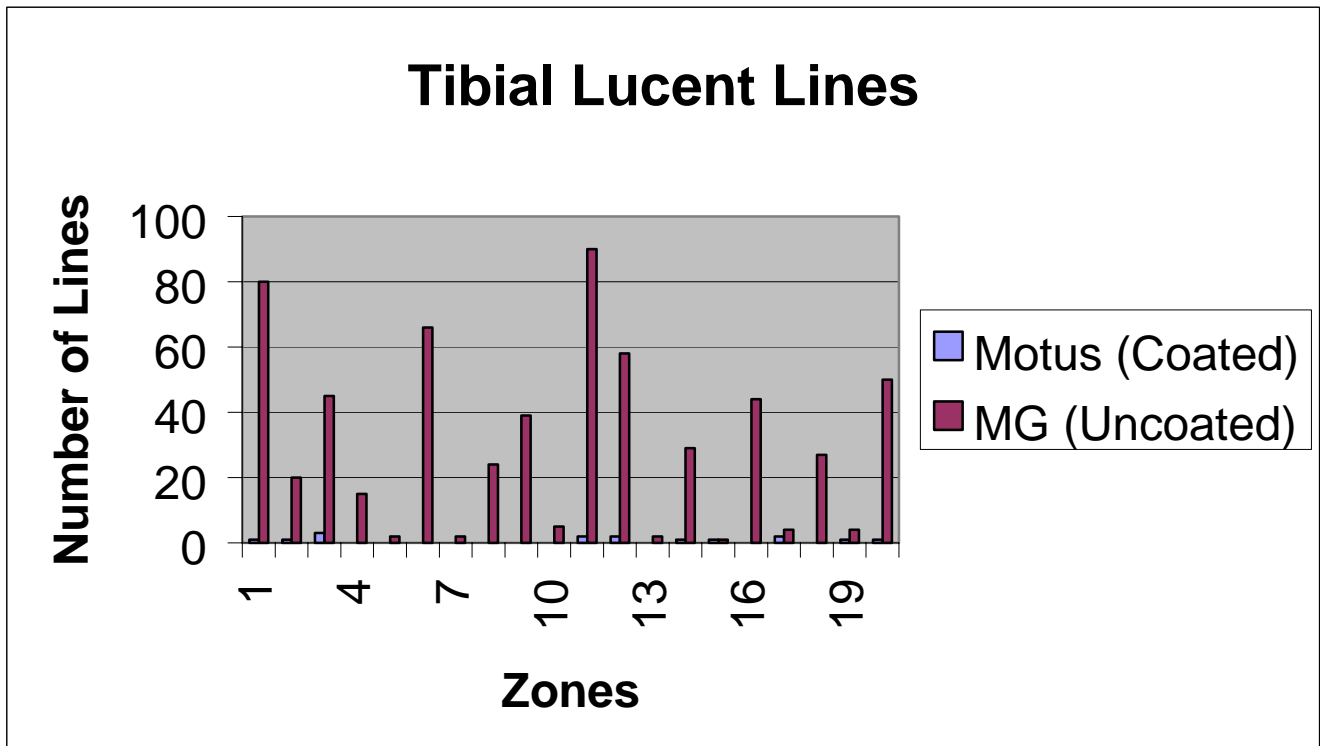
Figure 2 a) & b): Number of lucent lines in each zone (see Fig. 3 for zone location)

The radiographic results are shown in Figure 2 and the lucent zones locations are displayed in Figure 3. The assignment of zones is in the manner suggested by the Knee Society [12], to standardise the reporting of roentgenographic evaluations and scoring.

The authors agree that the presence of lucent lines can be benign, as shown by the 2 year knee function scores (188 HA coated vs. 181 uncoated) which are similar despite the marked differences in the lucent line rate. However, although the presence of a lucent line does not necessarily indicate either osteolysis or a loose component, it does signify an absence of osseointegration, which is the goal in any cementless arthroplasty. Only by collecting data in this way can the extent of osseointegration be monitored over time.

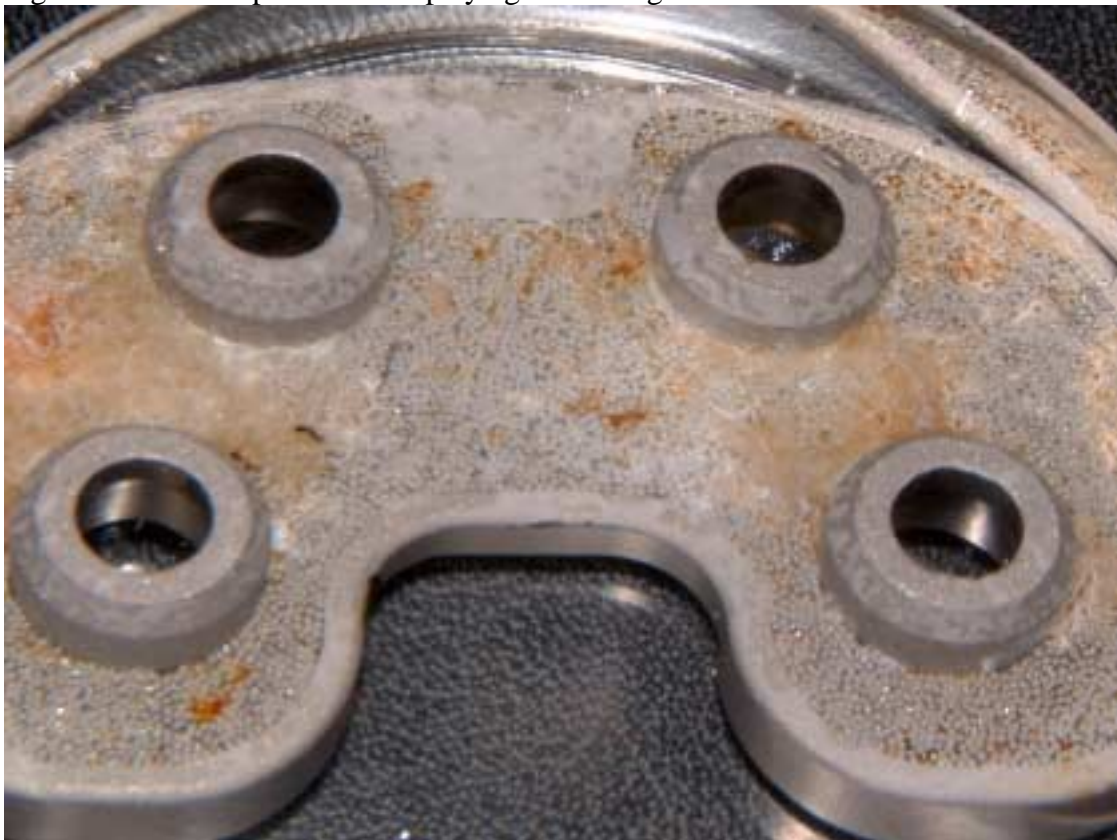
Figure 5. Retrieval prosthesis displaying osseointegration within the beaded surface

There has been suggestion [8] that HA coating of a beaded surface can lead to bead shedding. None has been seen in this study, although it was specifically examined for. The prosthesis used has beads only on the distal femoral surface, where there should be no shear, and the authors therefore believe that a coated, beaded distal surface should not pose a problem. The single retrieval specimen that has been obtained shows osseointegration within the beaded surface (Figure 5).
